YOUR INSPECTION REPORT

1234 Calgary Home
Calgary, AB

Wednesday, January 11, 2023

Report No. 4370

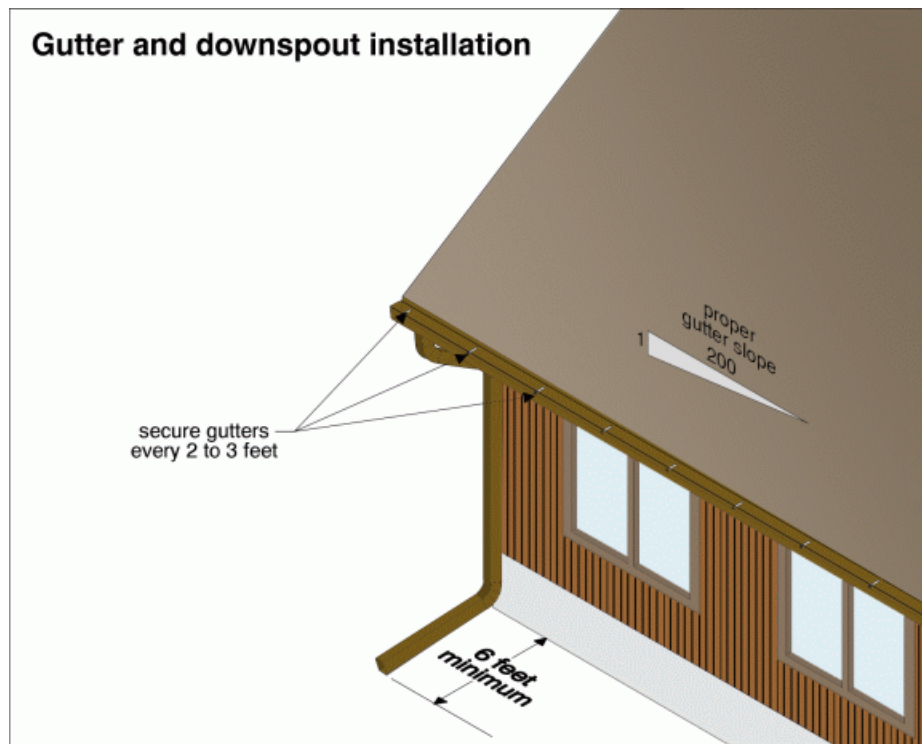
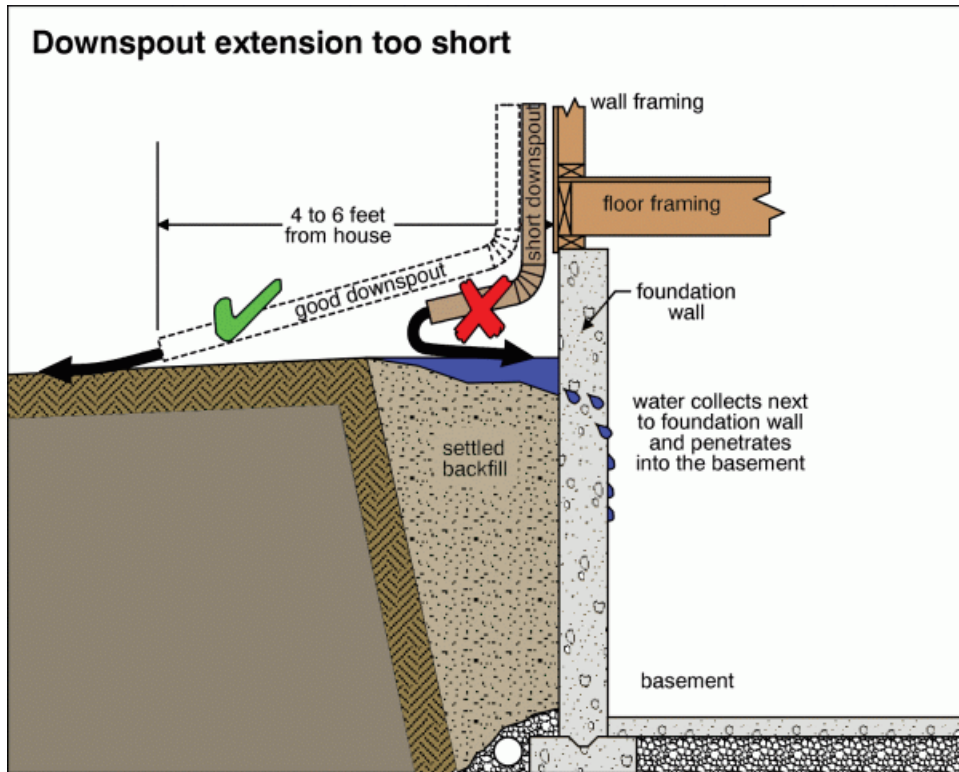
1. Discharge too close to building

Condition: • [Discharge too close to building](#)

Horizontal downspout extensions are disconnected. They should be re-connected to discharge water at least 4 to 10 feet away from home.

Implication(s): Chance of water damage to structure, finishes and contents

Location: Front Exterior Garage

- Settled or eroded grading should be repaired to ensure that water is directed away from the home.

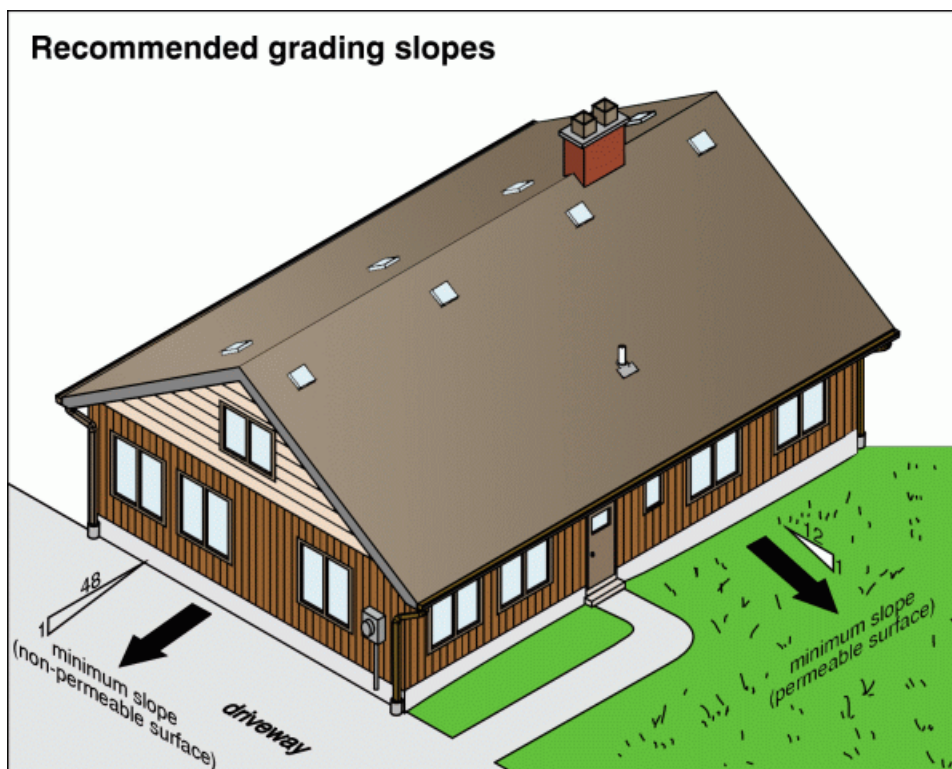
2.

Condition: • [Improper slope or drainage](#)

Walkway has settled towards the home, ideally it should be sloped away from the home to ensure precipitation / water flows away from the home.

Implication(s): Chance of water damage to structure, finishes and contents

Location: Front Exterior

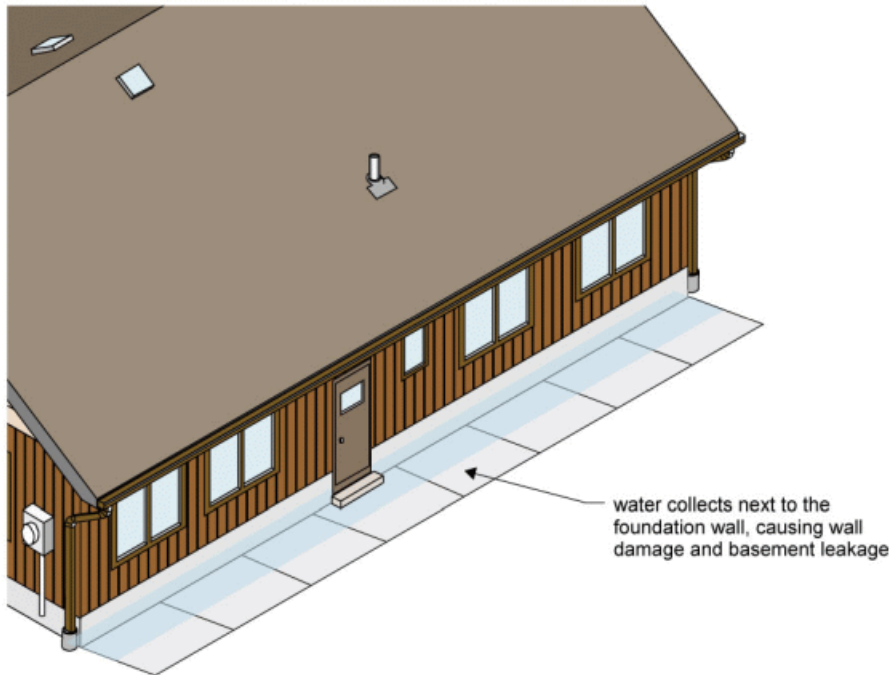
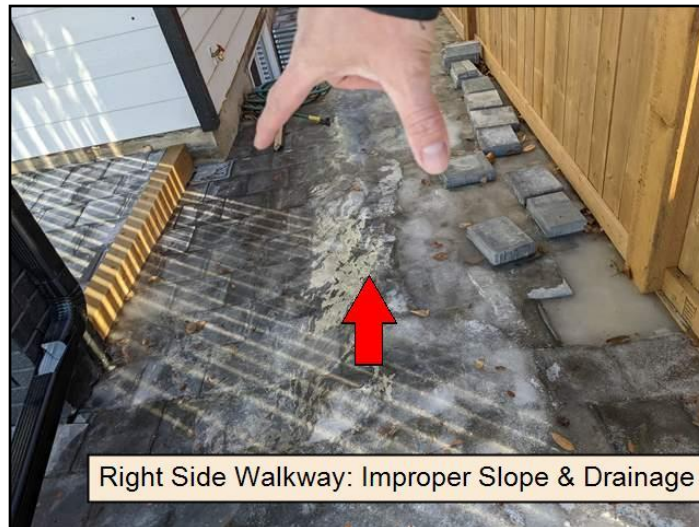
3. Improper slope or drainage

Walk/patio sloping towards house

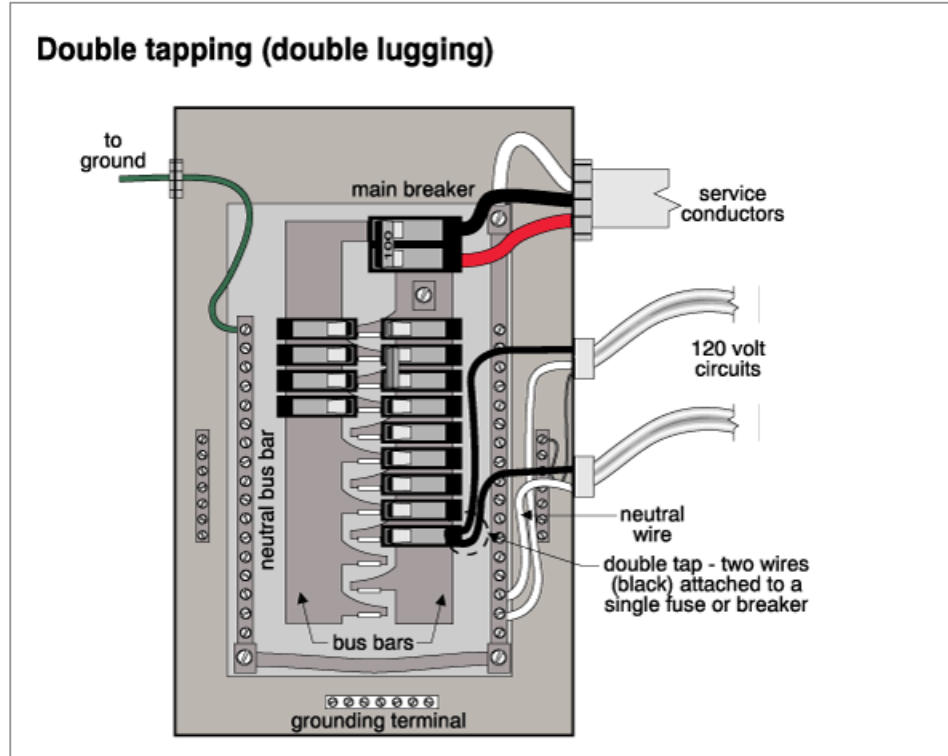
4. Double taps

Condition: • [Double taps](#)

Double Taps at electric panel. Each breaker should only have 1 wire secured to the lug, as multiple wires (double taps) can cause the connection to overheat and possibly cause a fire/electric shock if the connection becomes loose. It appears to have been installed this way for many years, and there were no signs of overheating or melted insulation.

Implication(s): Fire hazard

Location: Basement Main Panel

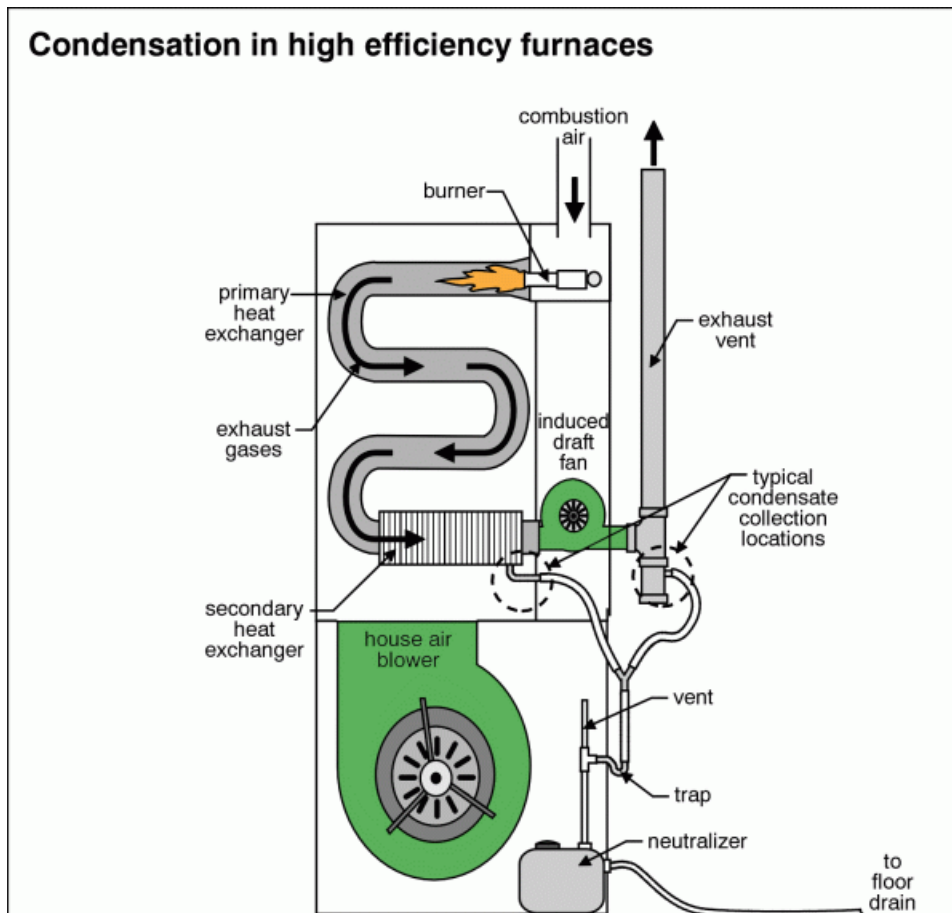
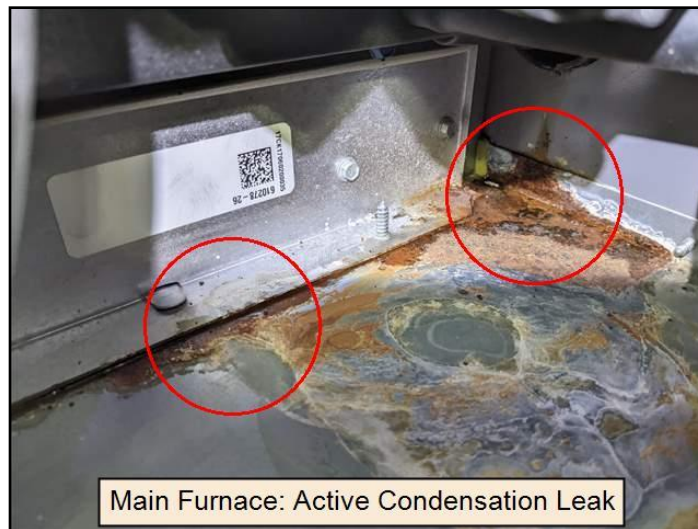
5. Condensate leak

Condition: • [Condensate leak](#)

Furnace needs to be serviced, it is leaking condensation inside the furnace cabinet. This can cause more issues if not addressed promptly, as the leaked condensation can rust through the cabinet and damage the electronics below.

Location: Basement - Main Furnace

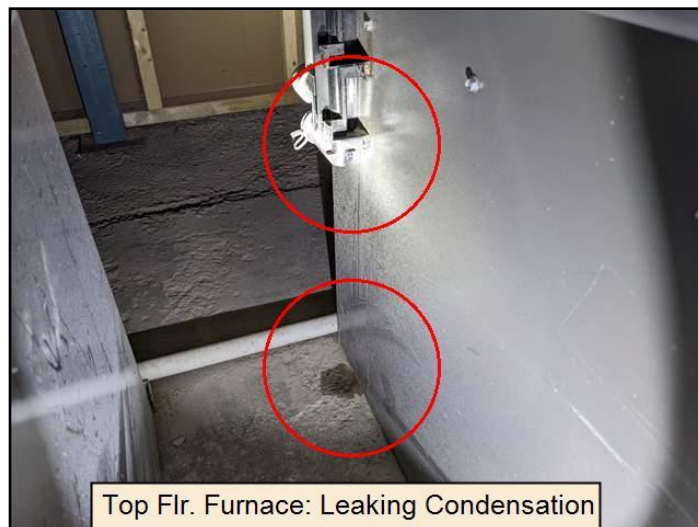
6. Condensate leak

Condition: • [Condensate leak](#)

Furnace is leaking (slowly) condensation at the exterior and is dripping on the floor. This should be repaired, no damage has yet been caused.

Location: Basement - Top Floor Furnace

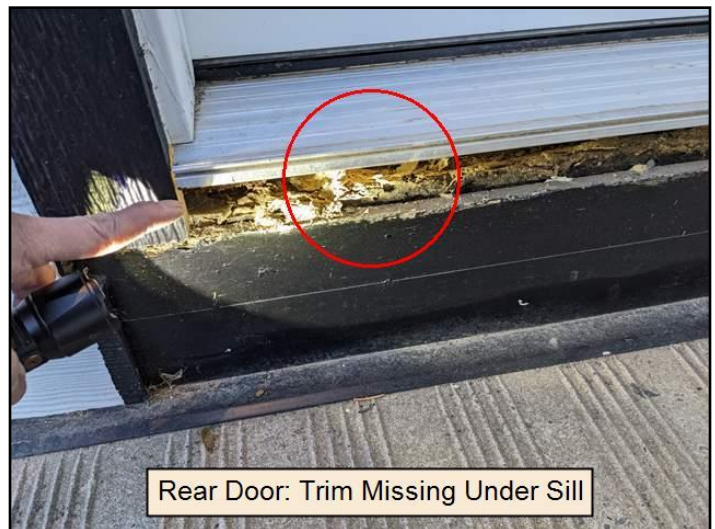
12.

Rear Door: Trim Missing Under Sill

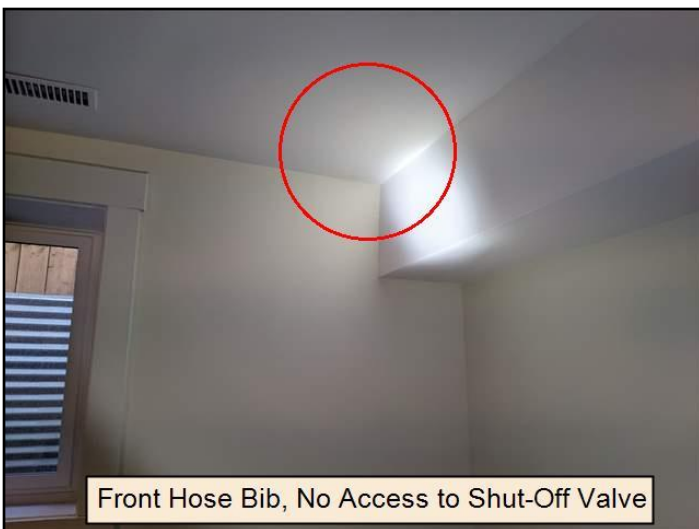
13.

Front Hose Bib, No Access to Shut-Off Valve

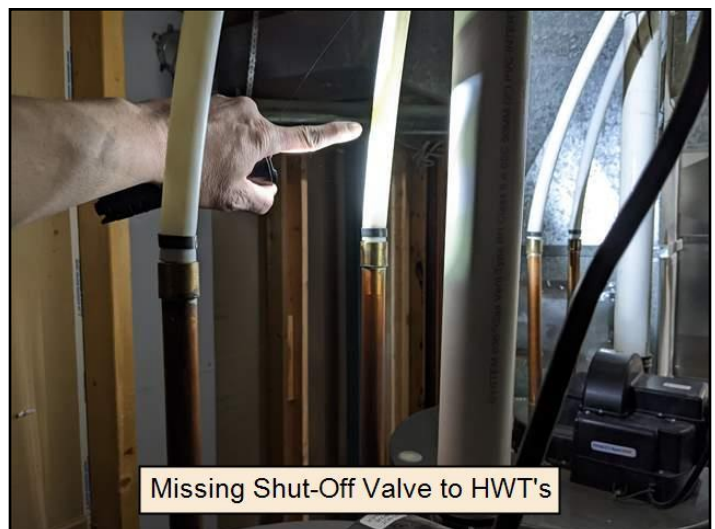
16.

Missing Shut-Off Valve to HWT's

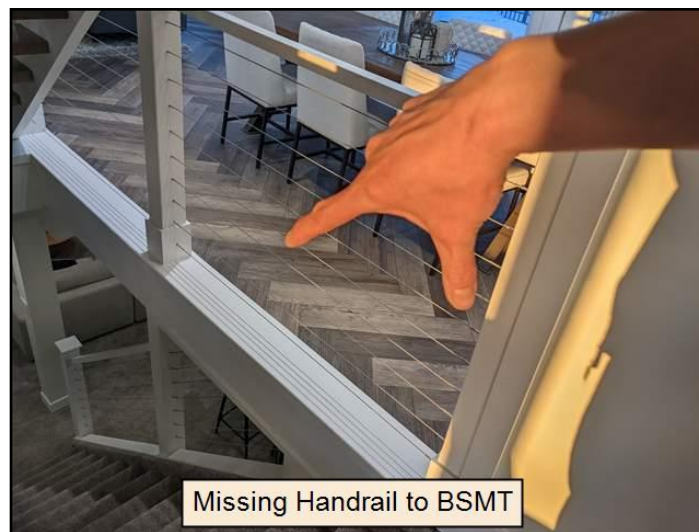
38. Missing

Condition: • [Missing](#)

Missing handrails should be installed, as this can prevent an accidental fall.

Implication(s): Fall hazard

Location: Basement

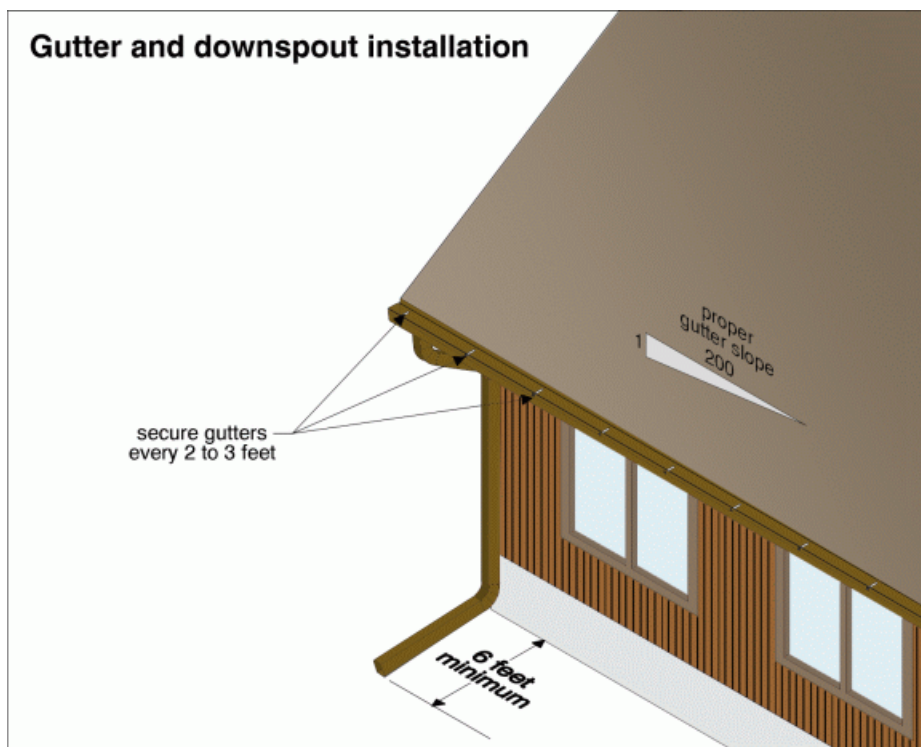
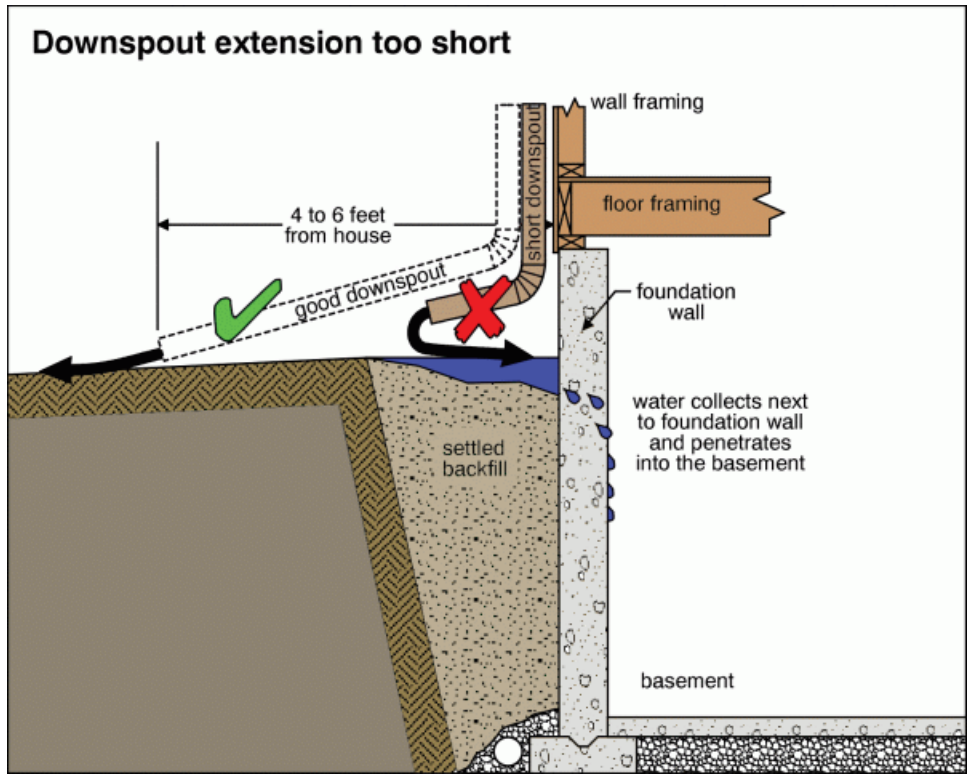
74. Discharge too close to building

1. Condition: • [Discharge too close to building](#)

Implication(s): Chance of water damage to structure, finishes and contents

- Settled or eroded grading should be repaired to ensure that water is directed away from the home.

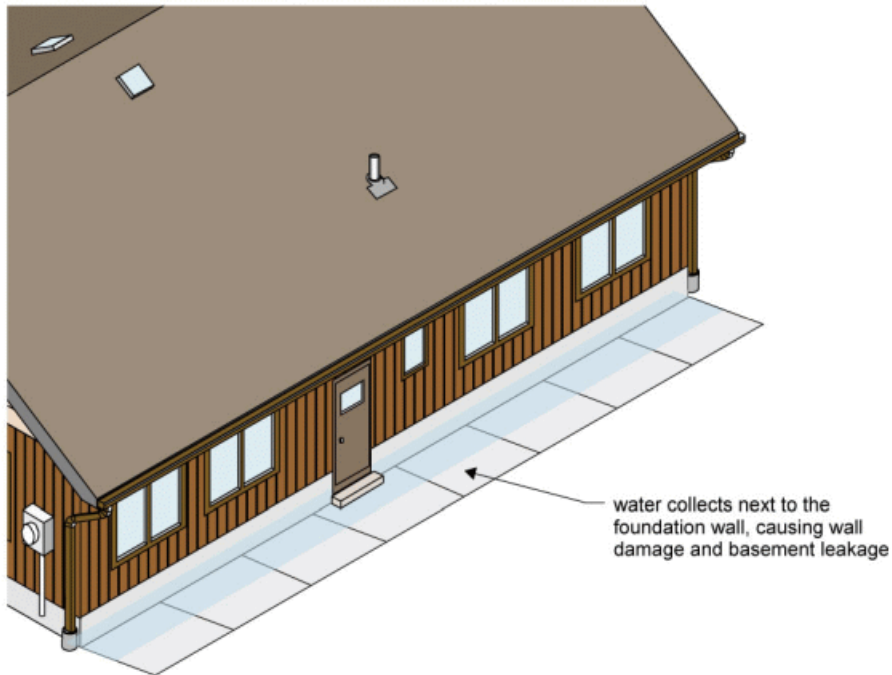
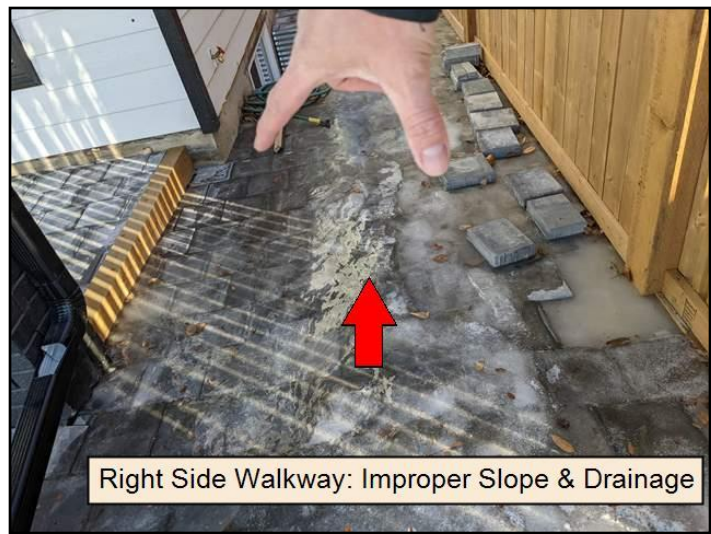
76. *Improper slope or drainage*

3. Condition: • [Improper slope or drainage](#)

Implication(s): Chance of water damage to structure, finishes and contents

Walk/patio sloping towards house

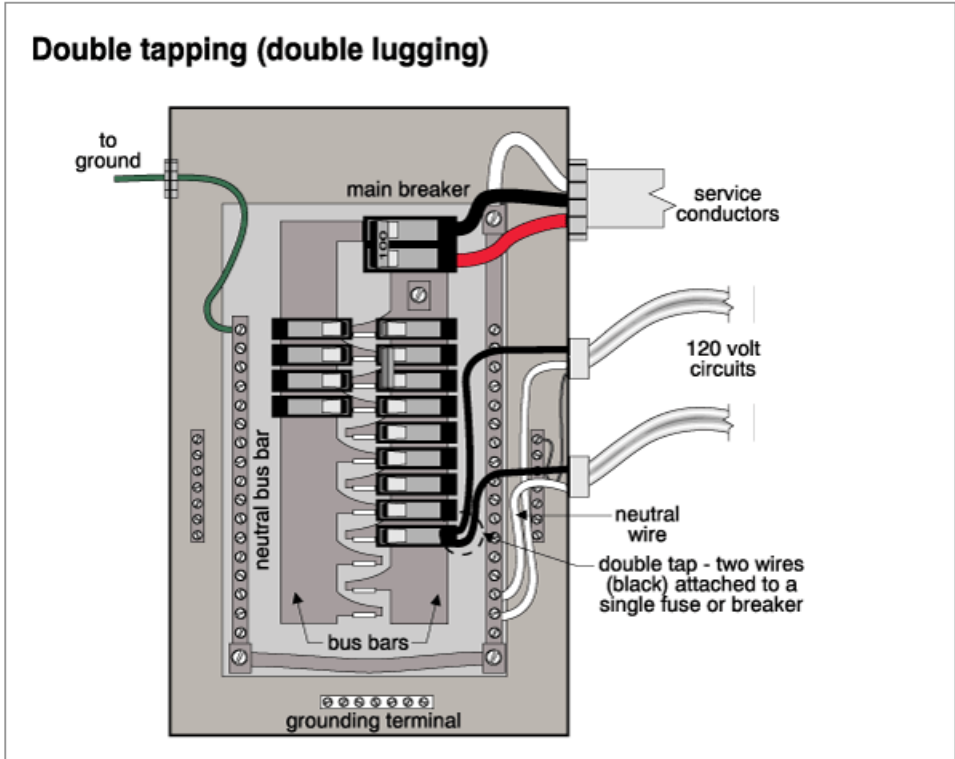
107. Double taps

4. Condition: • [Double taps](#)

Double Taps at electric panel. Each breaker should only have 1 wire secured to the lug, as multiple wires (double taps) can cause the connection to overheat and possibly cause a fire/electric shock if the connection becomes loose. It appears to have been installed this way for many years, and there were no signs of overheating or melted insulation.

Implication(s): Fire hazard

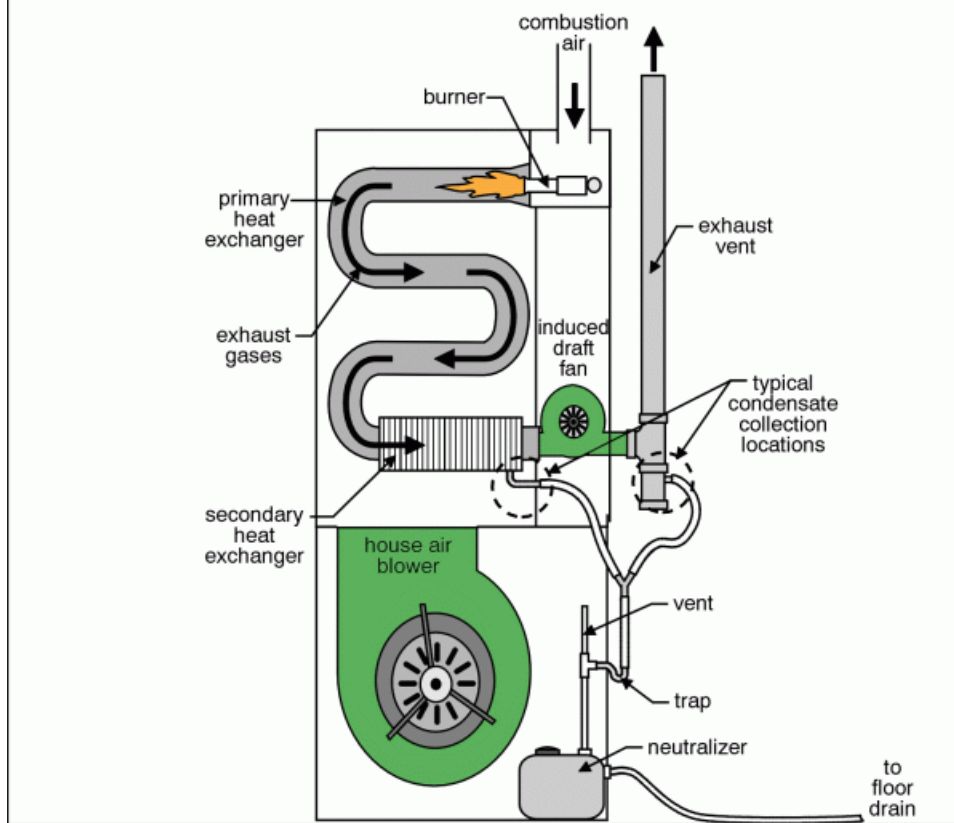
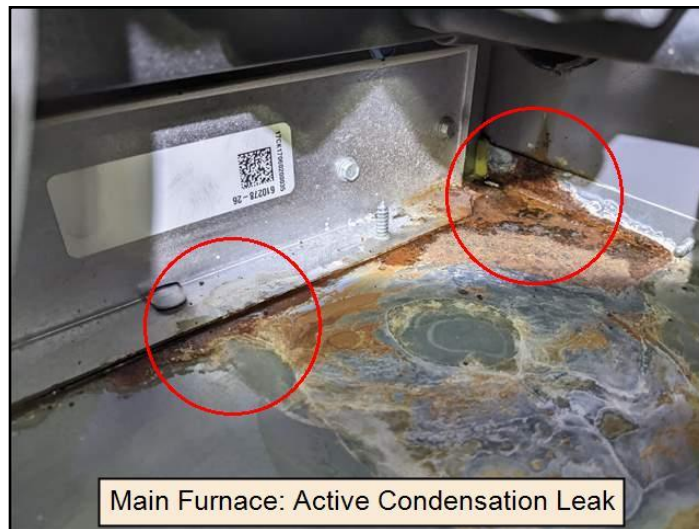
144. Condensate leak

5. Condition: • [Condensate leak](#)

Furnace needs to be serviced, it is leaking condensation inside the furnace cabinet. This can cause more issues if not addressed promptly, as the leaked condensation can rust through the cabinet and damage the electronics below.

Main Furnace: Active Condensation Leak

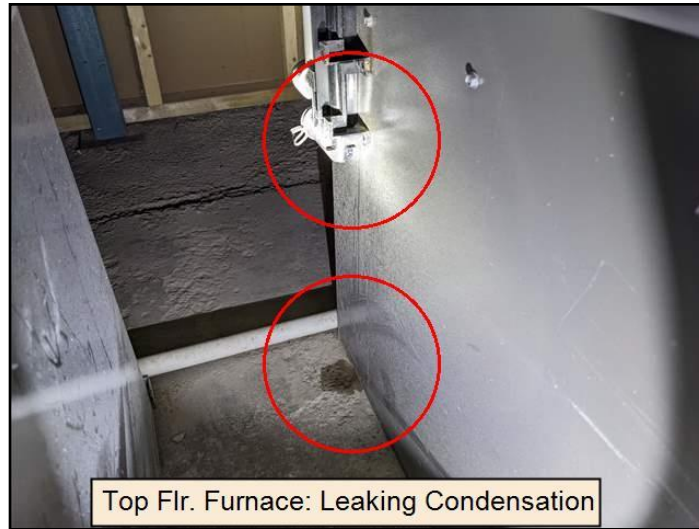
145. Condensate leak

6. Condition: • [Condensate leak](#)

Furnace is leaking (slowly) condensation at the exterior and is dripping on the floor. This should be repaired, no damage has yet been caused.

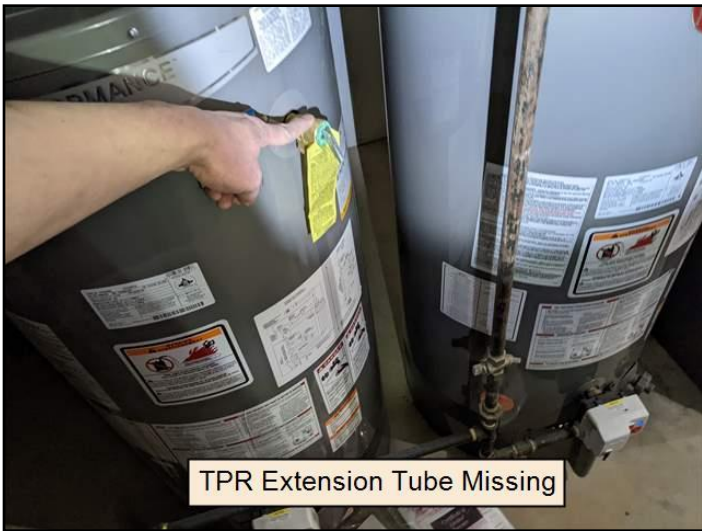
163. Discharge tube missing

8. Condition: • [Discharge tube missing](#)

TPR Valve extension tube is missing. There is a tube that threads into the TPR Valve and extends down near floor level. This prevents scalding if the valve was to ever open (from over pressure / heat).

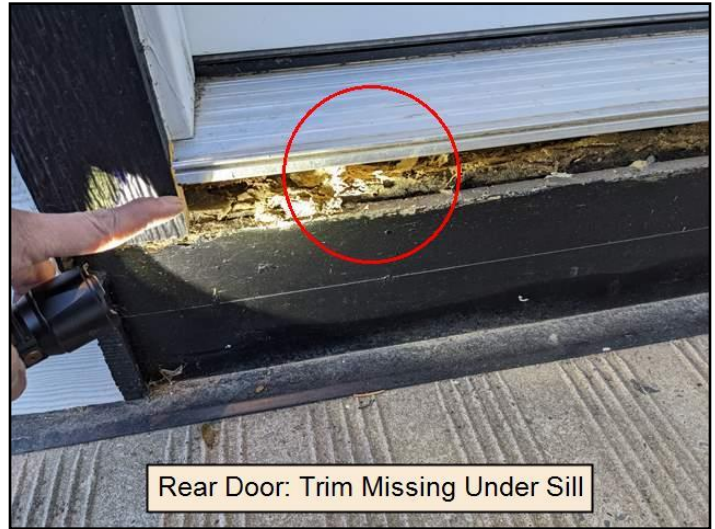
190.

Rear Door: Trim Missing Under Sill

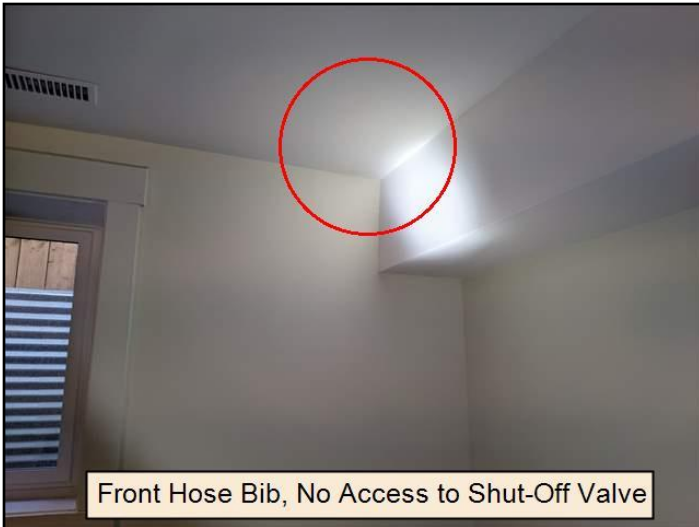
191.

Front Hose Bib, No Access to Shut-Off Valve

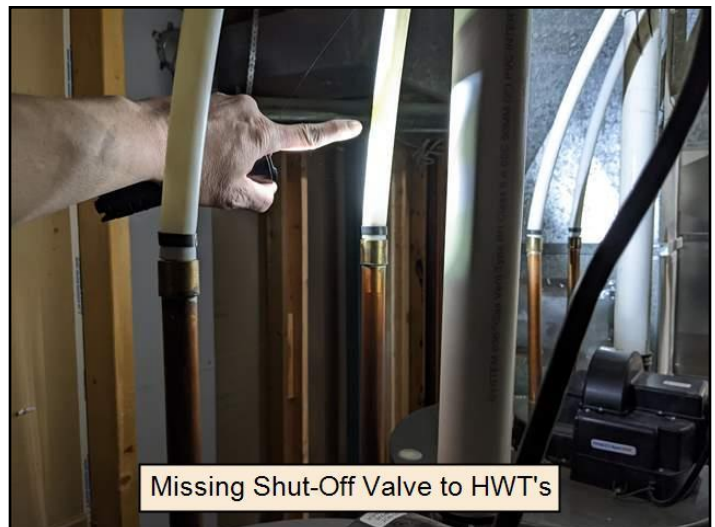
194.

Missing Shut-Off Valve to HWT's

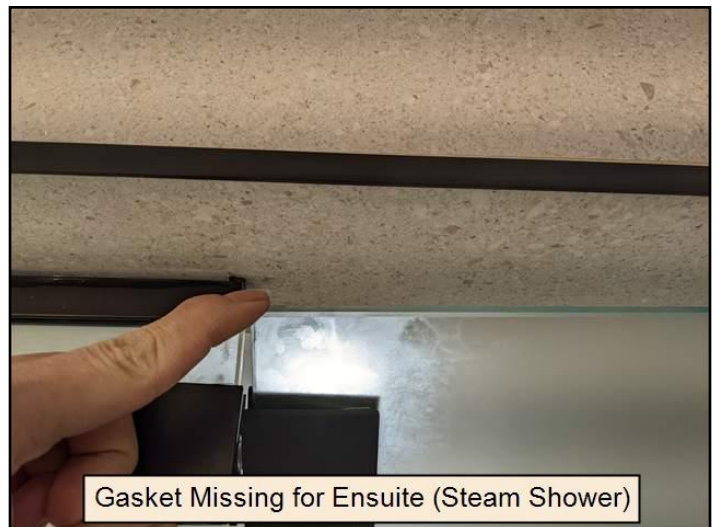
212.

Gasket Missing for Ensuite (Steam Shower)

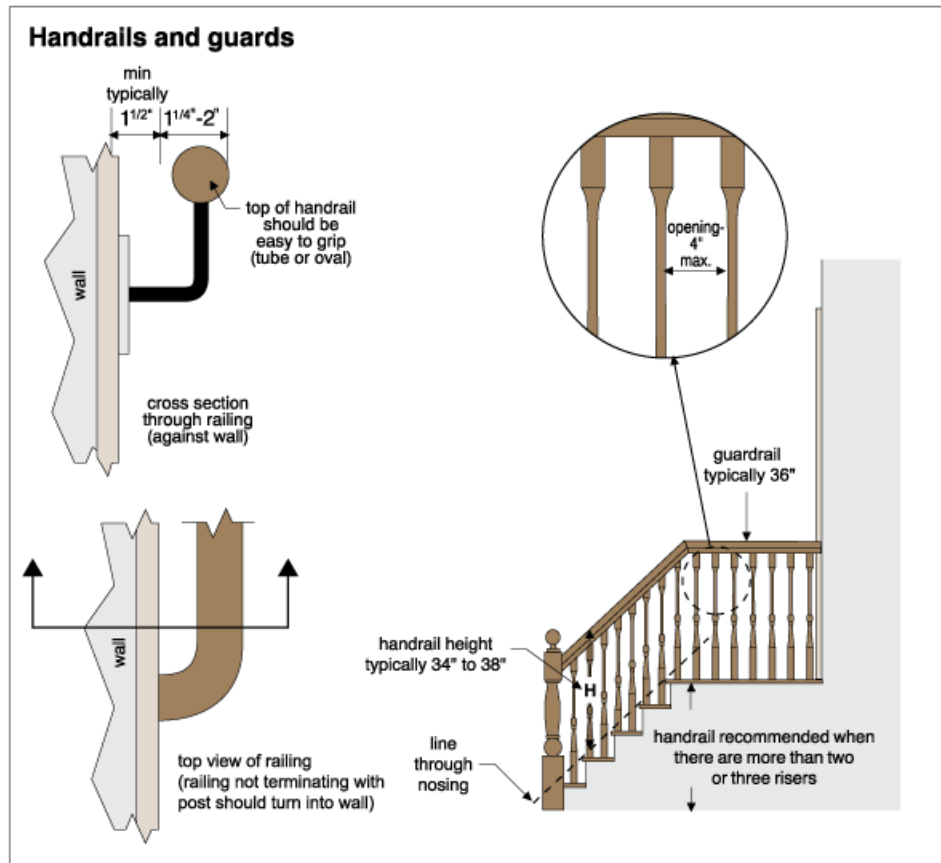
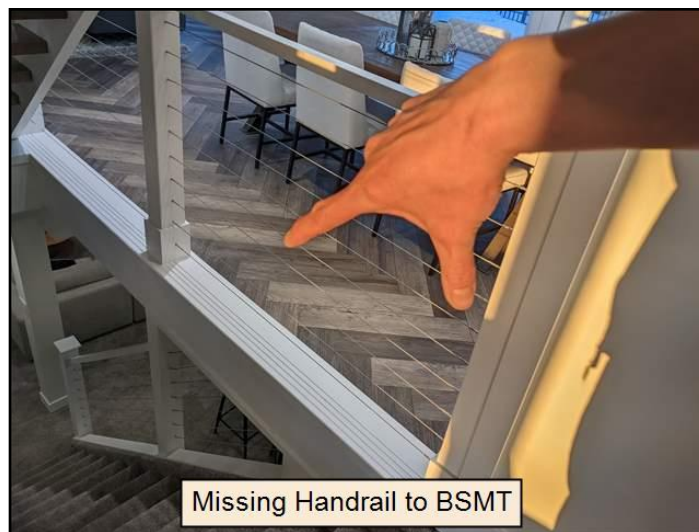
216. Missing

10. Condition: • [Missing](#)

Missing handrails should be installed, as this can prevent an accidental fall.

Implication(s): Fall hazard
