YOUR INSPECTION REPORT

1234 Calgary Home
Calgary, AB

Wednesday, January 11, 2023

Report No. 4370

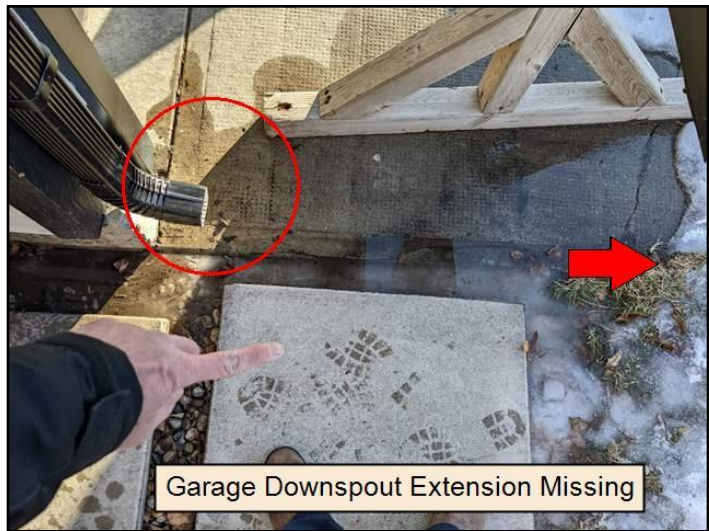
74. Discharge too close to building

1. Condition: • [Discharge too close to building](#)

Implication(s): Chance of water damage to structure, finishes and contents

- Settled or eroded grading should be repaired to ensure that water is directed away from the home.
