YOUR INSPECTION REPORT

1234 Calgary Home
Calgary, AB

Wednesday, January 11, 2023

Report No. 4370

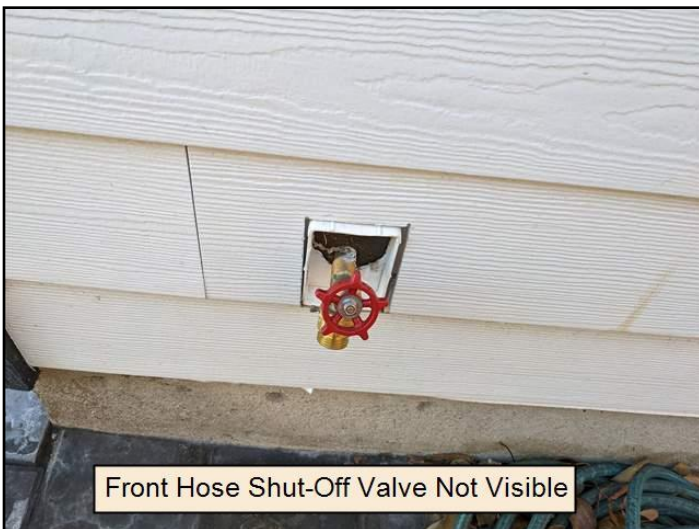
11.

Front Hose Shut-Off Valve Not Visible

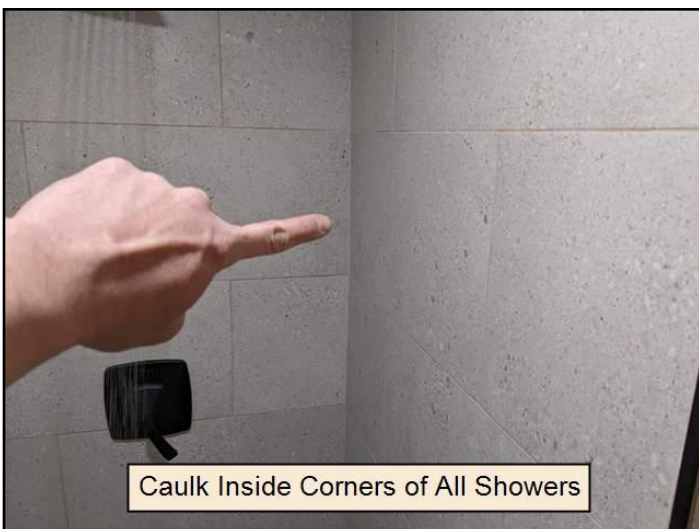
15.

Caulk Inside Corners of All Showers

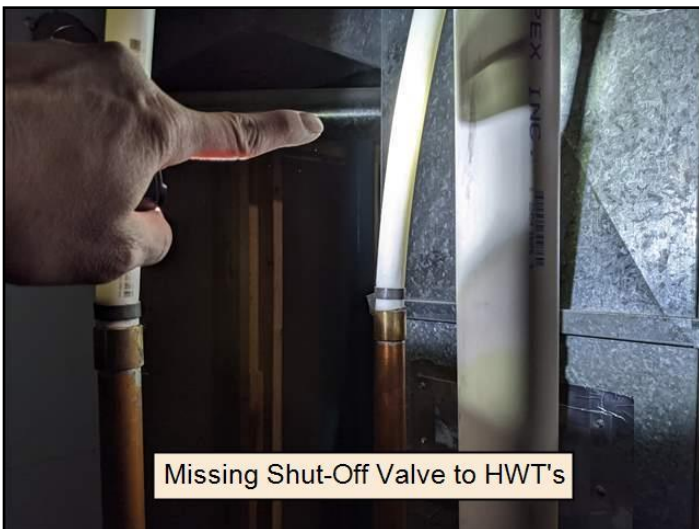
Missing Shut-Off Valve to HWT's

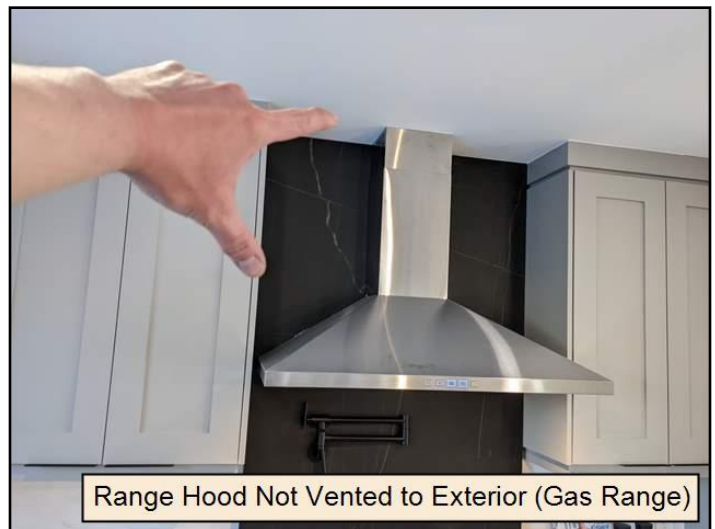
Range Hood Not Vented to Exterior (Gas Range)

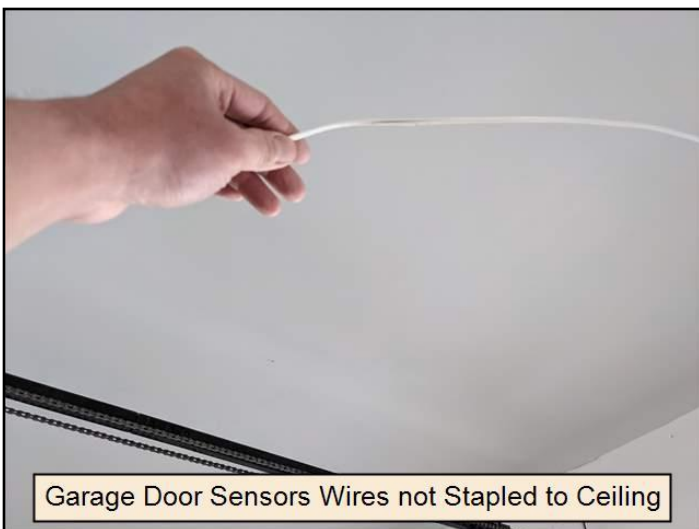
Garage Door Sensors Wires not Stapled to Ceiling

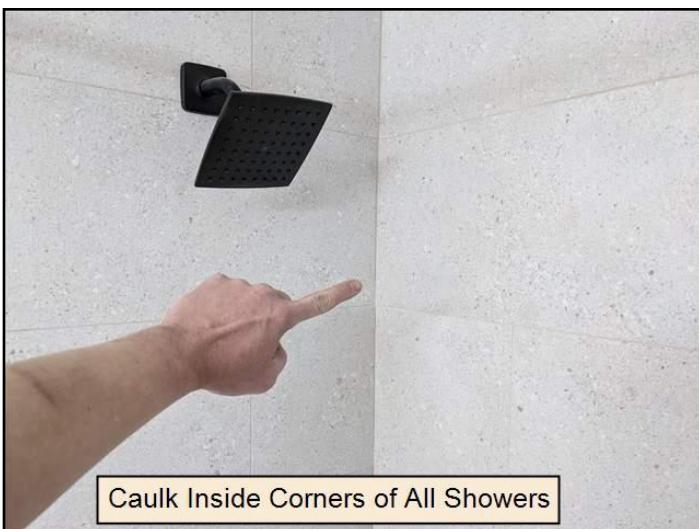
Caulk Inside Corners of All Showers

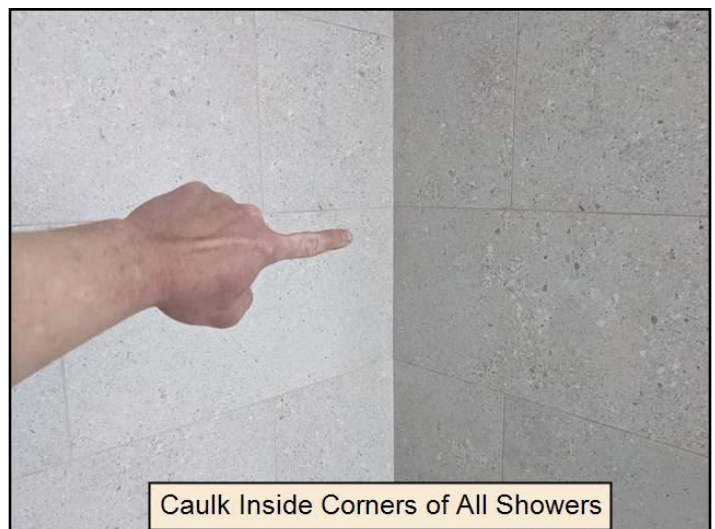
Caulk Inside Corners of All Showers

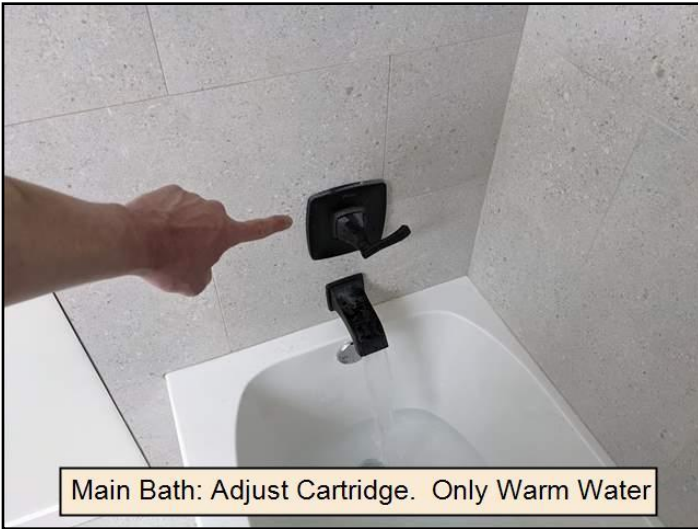
Main Bath: Adjust Cartridge. Only Warm Water

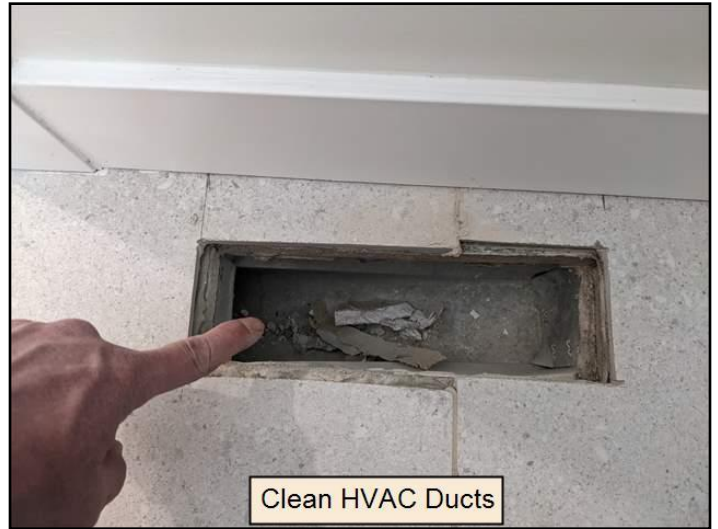
Clean HVAC Ducts

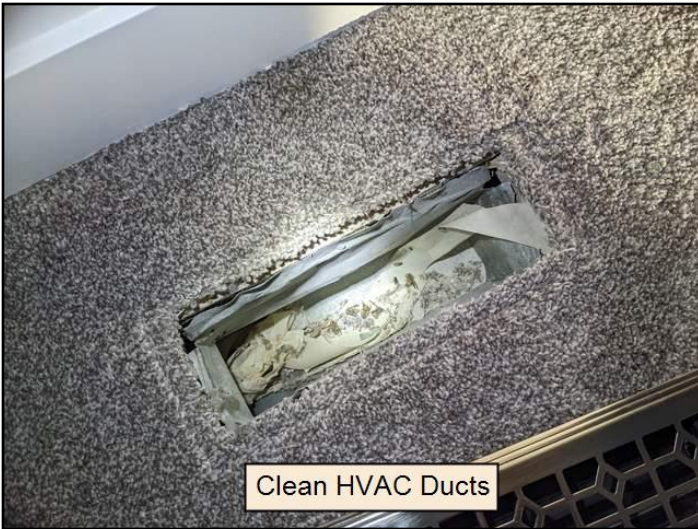
Clean HVAC Ducts

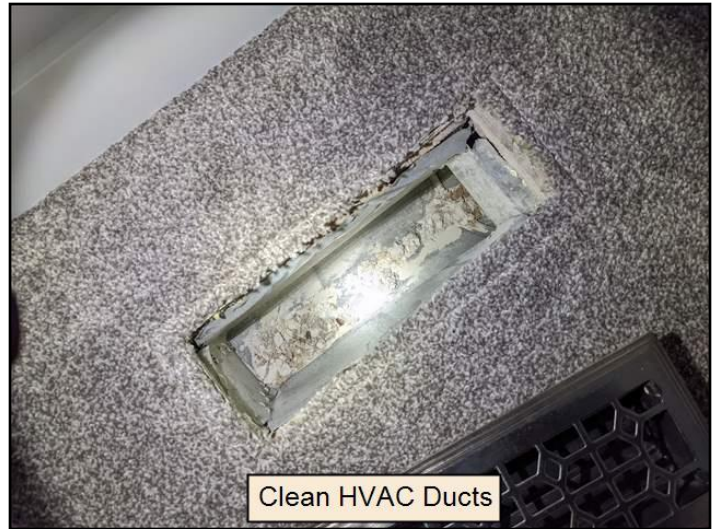
Clean HVAC Ducts

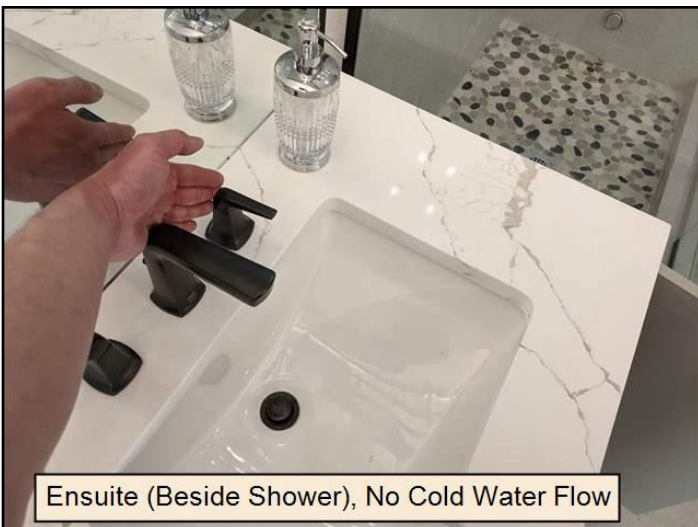
Ensuite (Beside Shower), No Cold Water Flow

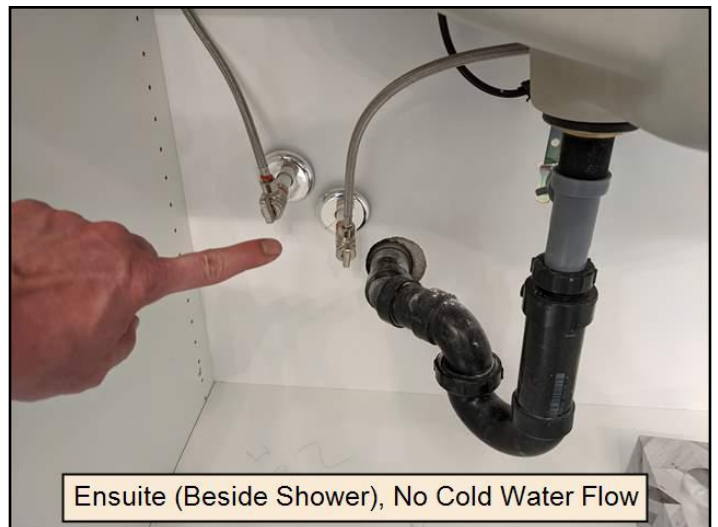
Ensuite (Beside Shower), No Cold Water Flow

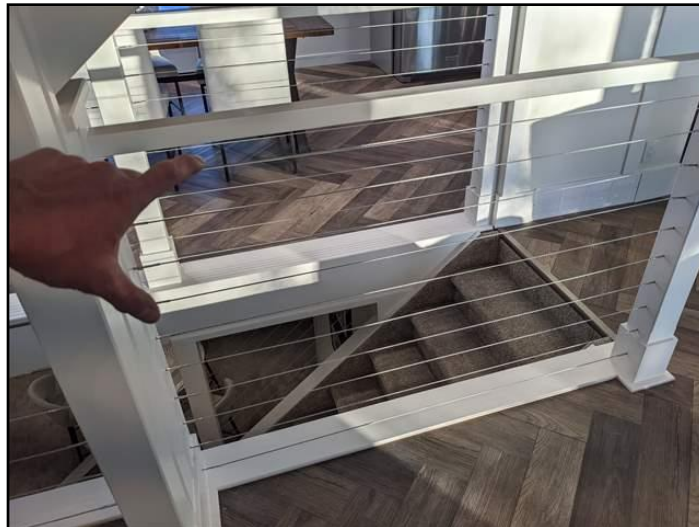
39. *Easy to climb*

Condition: • [Easy to climb](#)

Implication(s): Fall hazard

Task: Improve

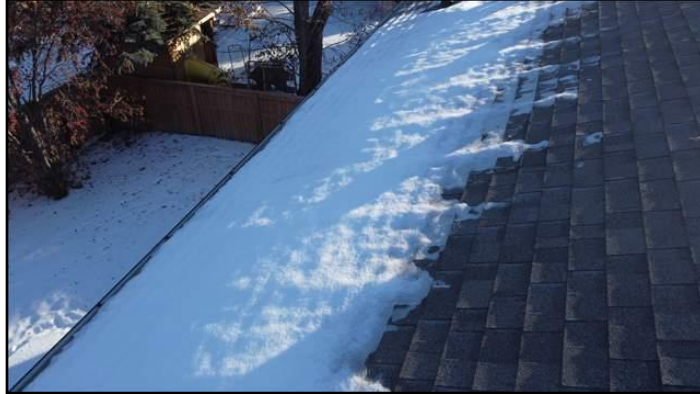
58. Snow

Snow limited full visibility of the entire roof surface.

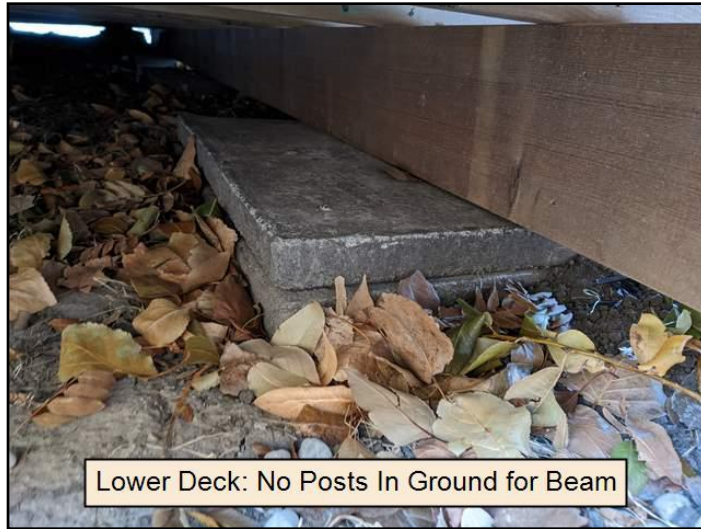
75.

2. **Condition:** • Lower deck beam sits on sidewalk blocks at grade. This can cause the deck to heave / settle as the ground can settle or frost heave. Monitor and repair as needed. Ideally, posts or piles should be installed past the frost line (lower than 4') to prevent heaving or settling.

Task: Monitor, improve as required

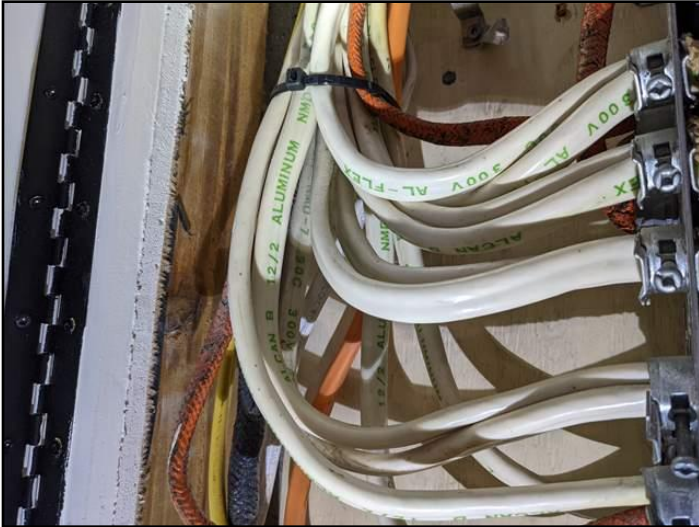
Aluminum wiring is present at the electrical panel. Breakers are CU/AL Compatible. Receptacles and switches were not tested for compatibility. Aluminum wiring is considered a safe material, as long as AL compatible switches and receptacles are used. Otherwise, a copper pig-tail should be used at each receptacle/switch.

- There were no indications of overheating at the electric distribution panel.

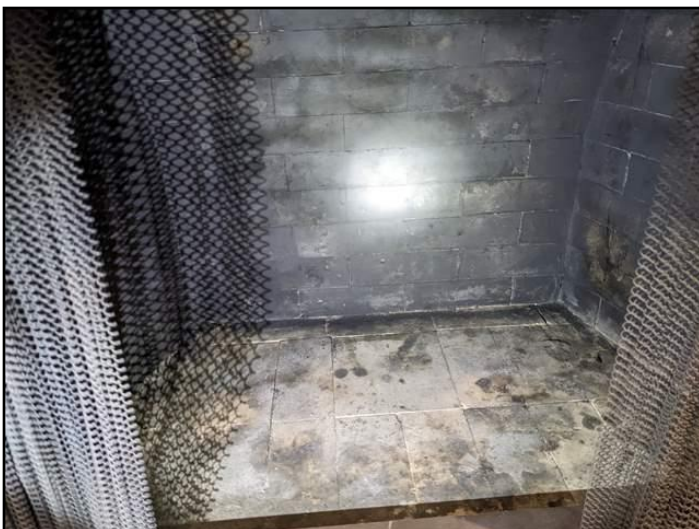
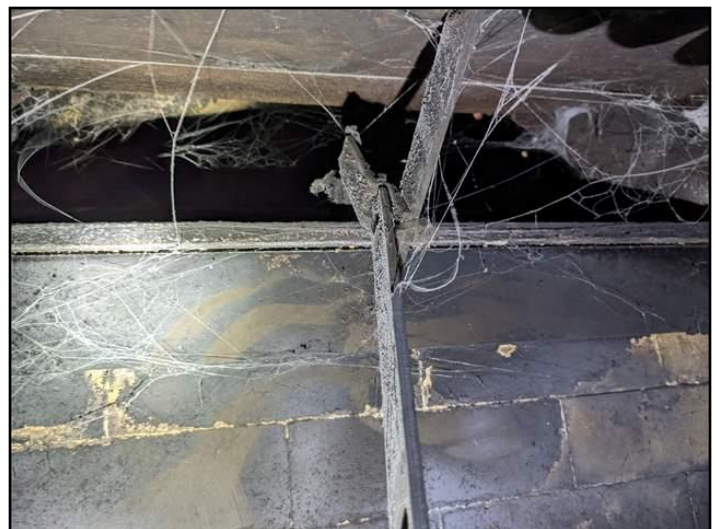
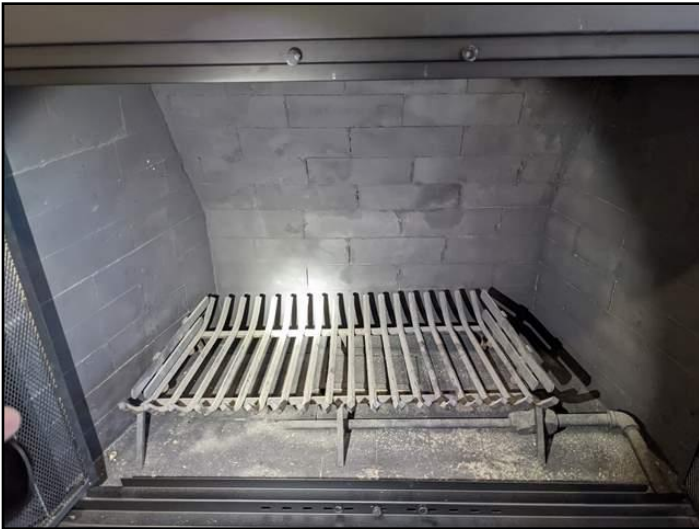
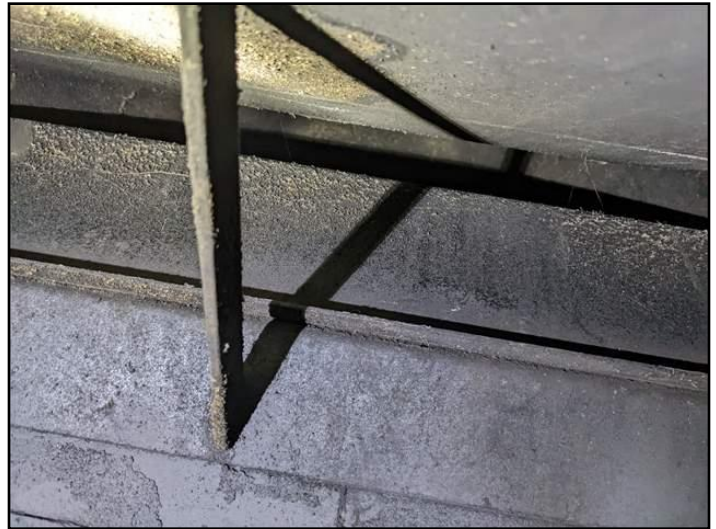
- Chimney appears to be clean during the inspection, and a chimney sweep is not required at this time.

Wood Burning Fireplace. Recommend having chimney swept to remove creosote buildup each fall before the heating season if it is used extensively. A chimney sweep may not be needed annually, but is dependant on usage of the wood fireplace.

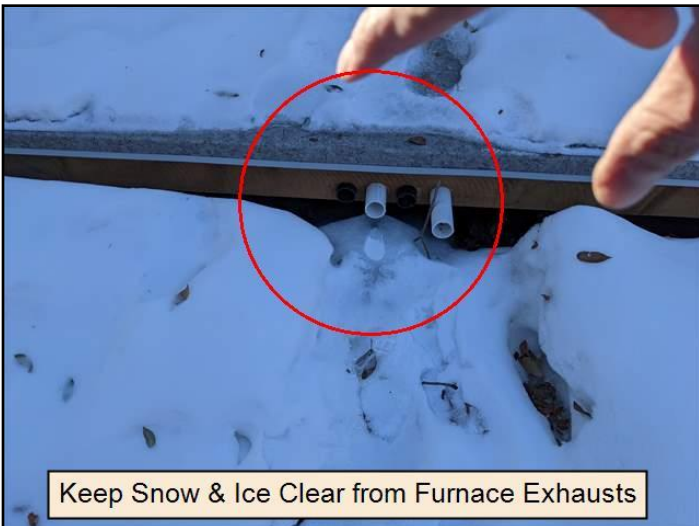
Clear snow away from furnace exhausts and air intakes. Installation is very close to grade, it may have been approved by the City of Calgary based on the Permit in the basement. Otherwise, you can glue new System 636 Elbows and extensions for the exhaust pipes to be elevated higher.

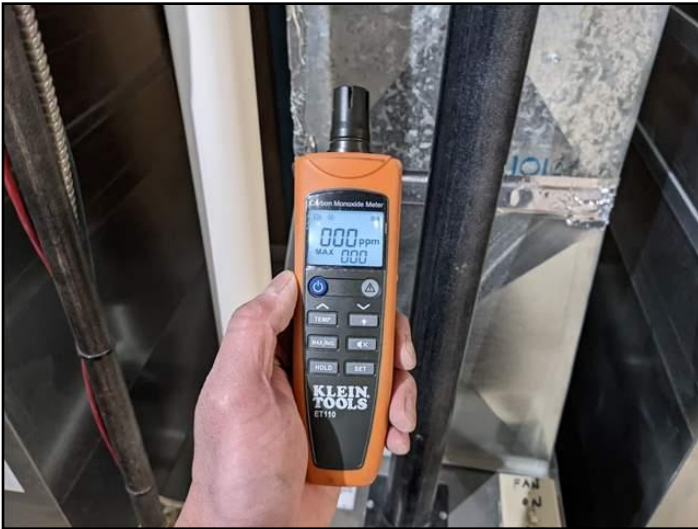
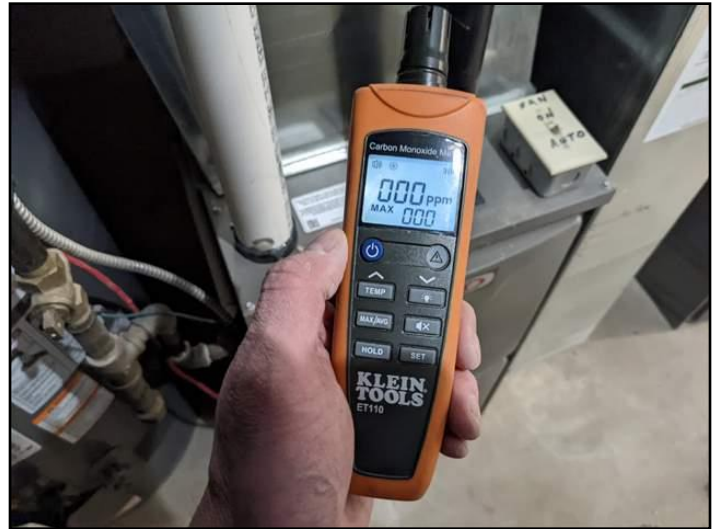
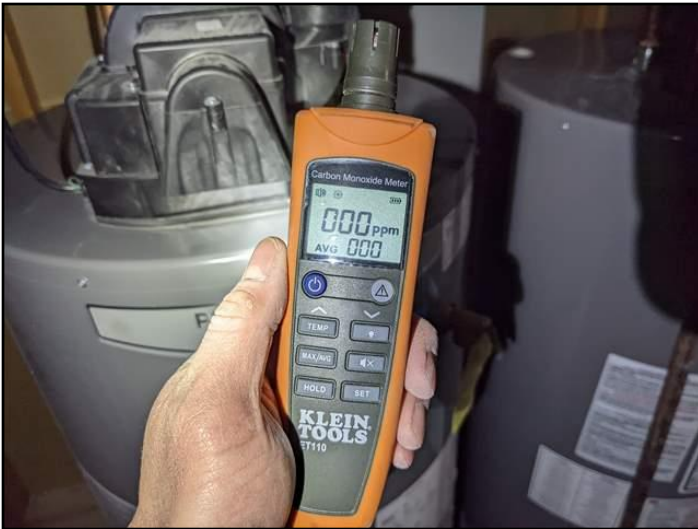
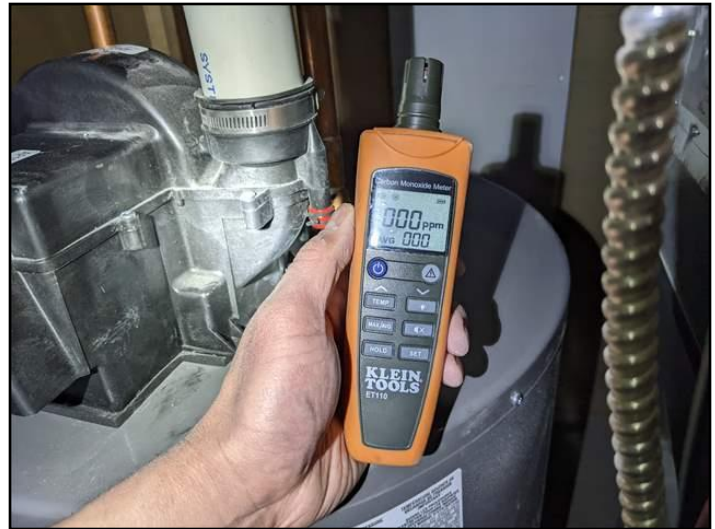
- 0 parts per million - approximate

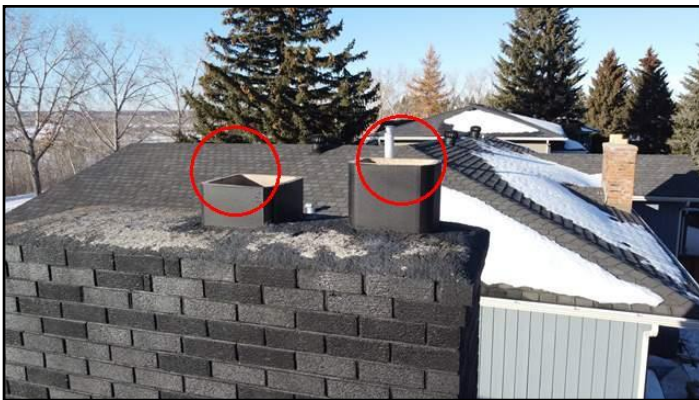
7. Condition: • Spark Arrester Caps are recommend for the fireplace flues. This can prevent precipitation from directly falling down into the chimney, and also to prevent rodents such as birds and squirrels from entering.

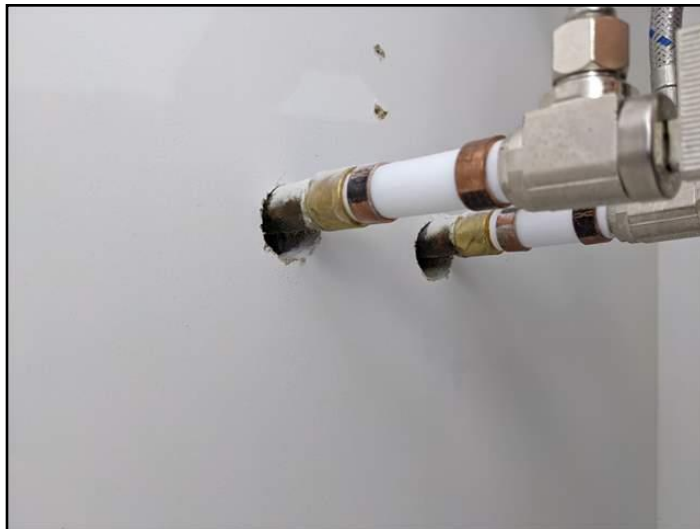
153. Copper

Copper pipes are present, but it appears that more than 50% of it has been upgraded to PEX

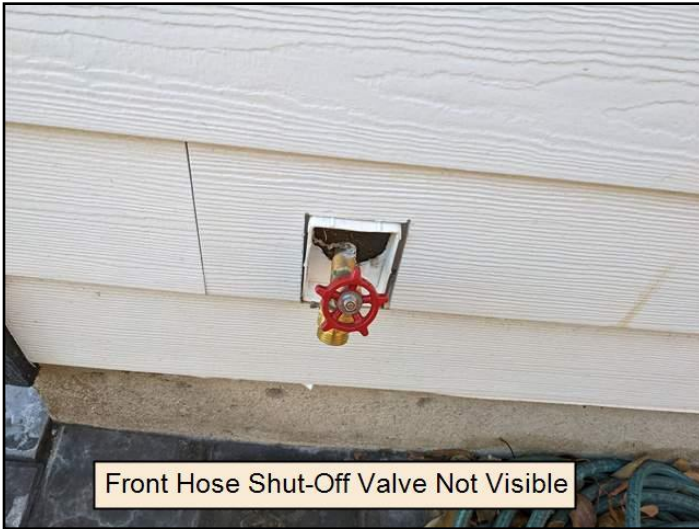
189.

Front Hose Shut-Off Valve Not Visible

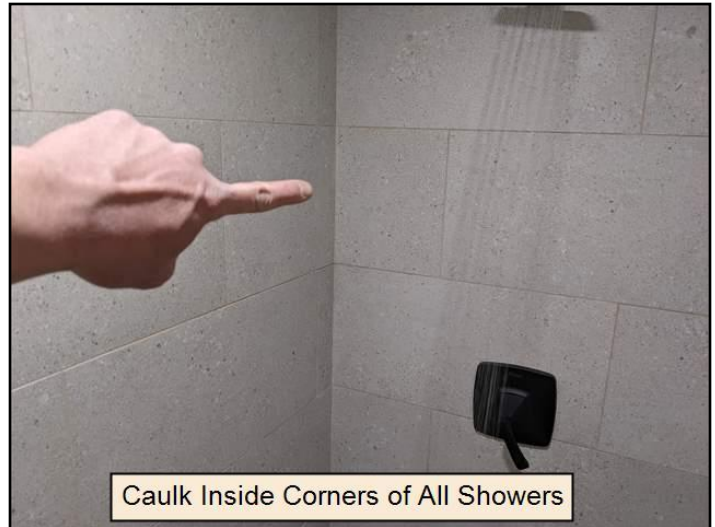
192.

Caulk Inside Corners of All Showers

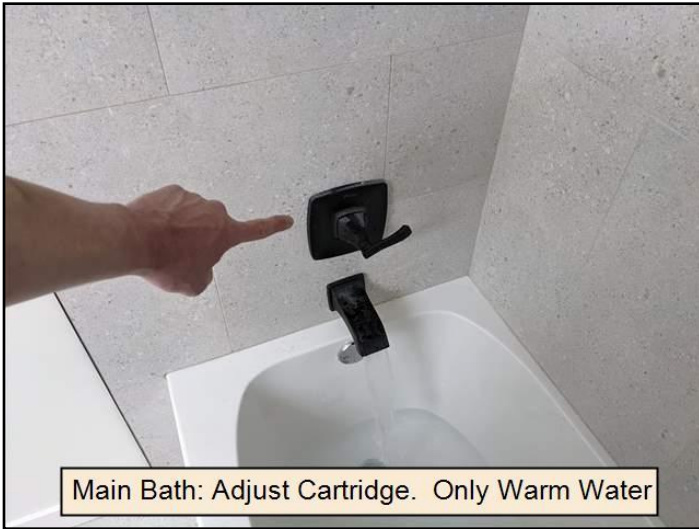
Main Bath: Adjust Cartridge. Only Warm Water

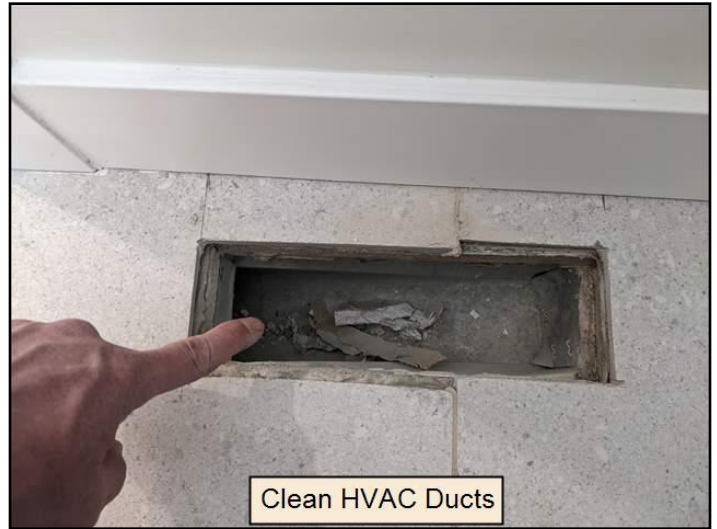
201.

Clean HVAC Ducts

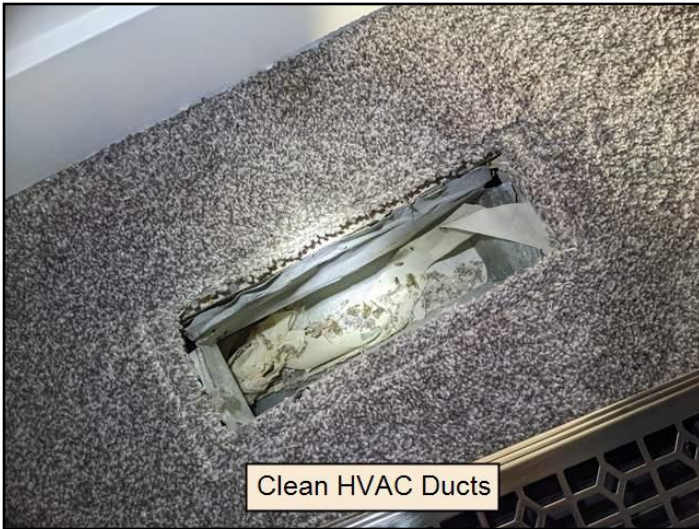
202.

Clean HVAC Ducts

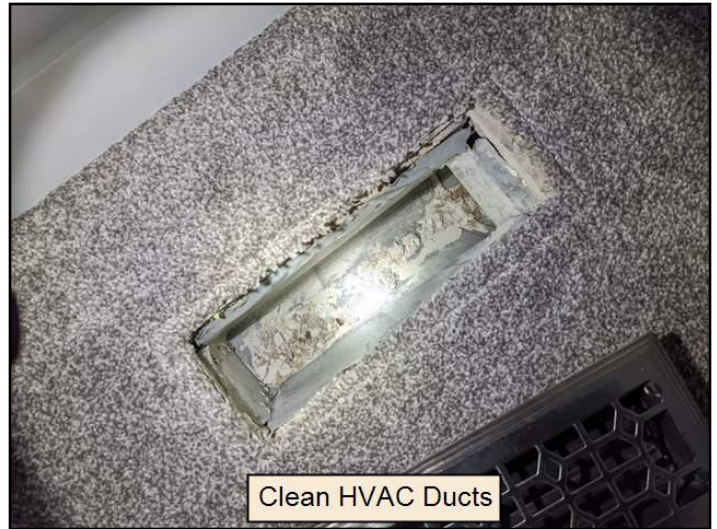
203.

Clean HVAC Ducts

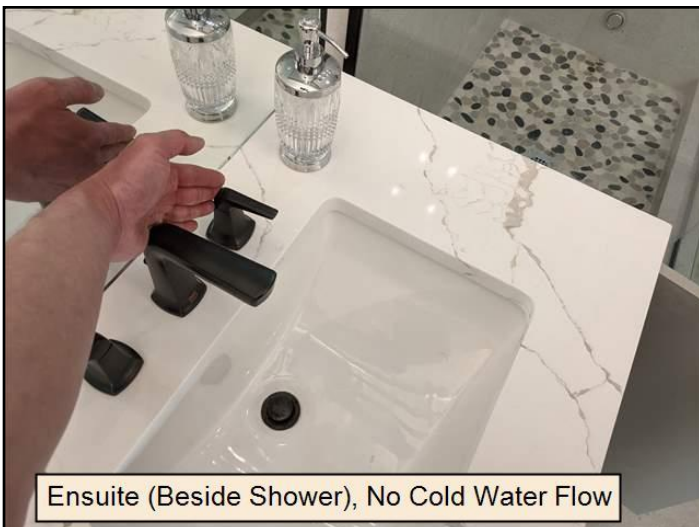
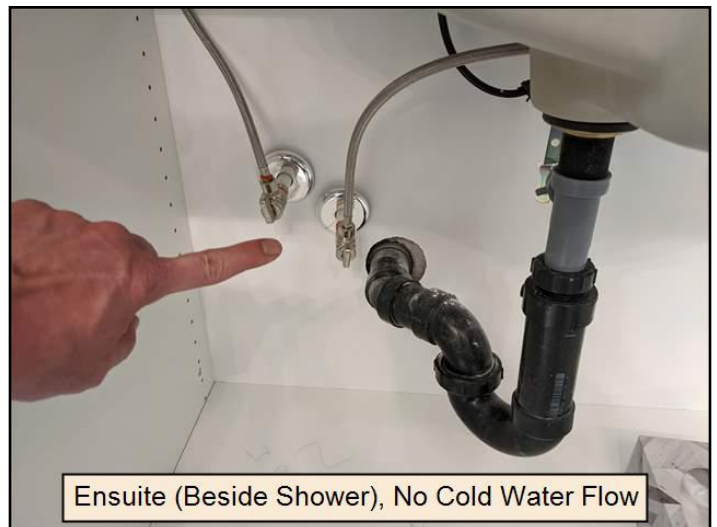
Ensuite (Beside Shower), No Cold Water Flow

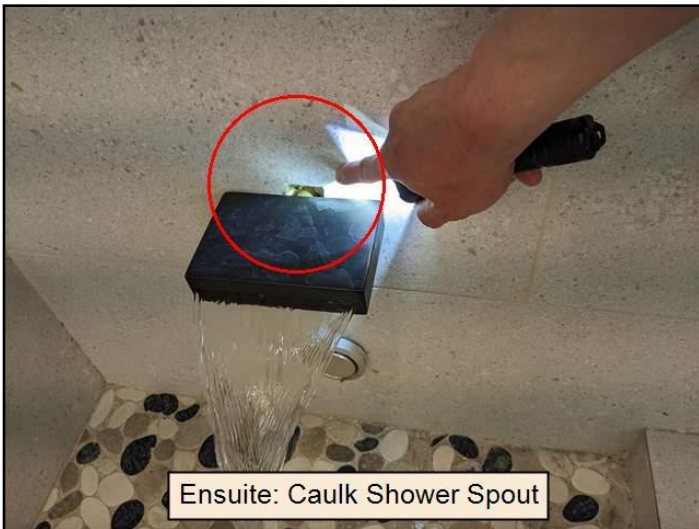
207.

Ensuite: Caulk Shower Spout

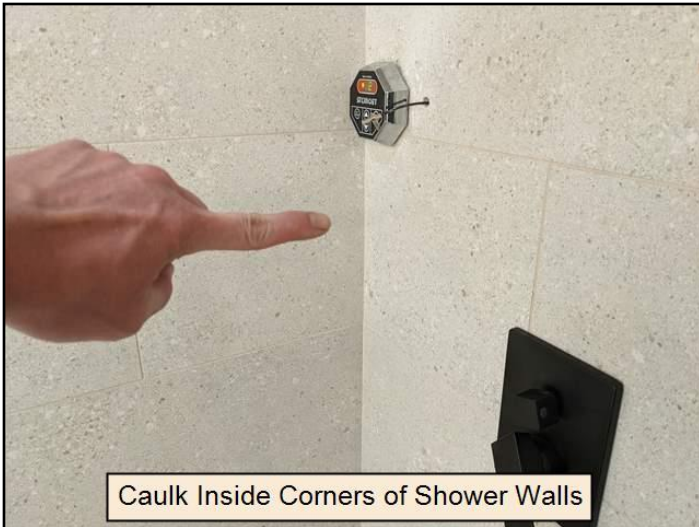
209.

Caulk Inside Corners of Shower Walls

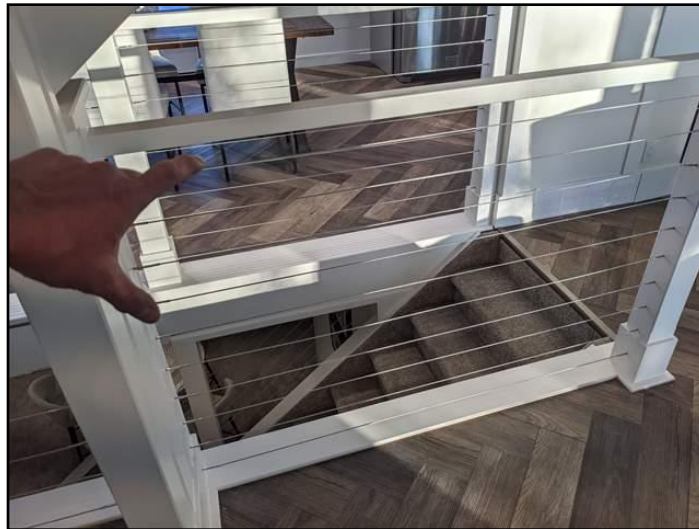
11. Condition: • [Easy to climb](#)

Implication(s): Fall hazard

217. *Easy to climb*

Task: Improve
